# Replacing Front Fenders on a BMW 3.0CS

July 6, 2010

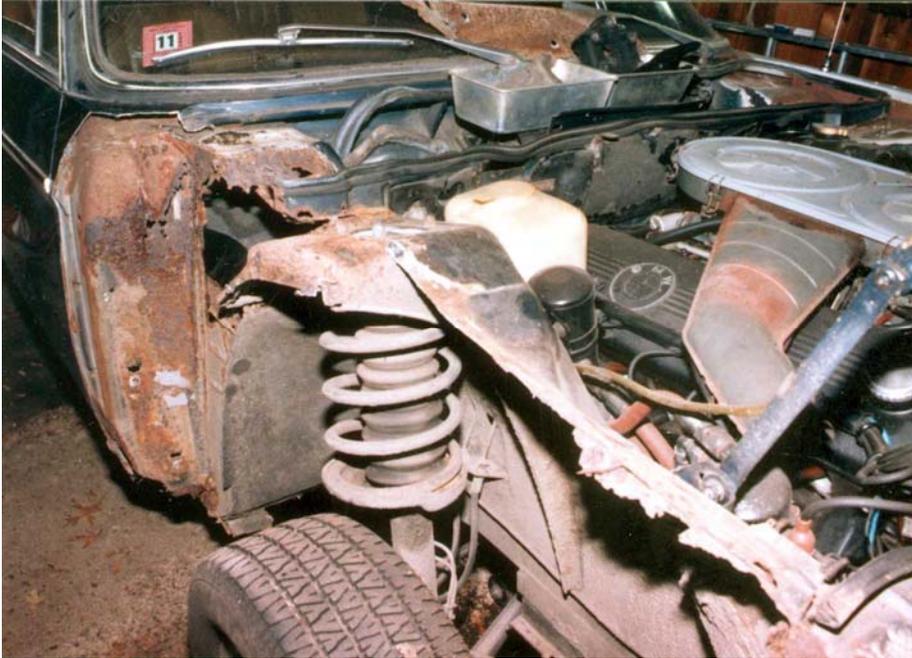
Be prepared for the carnage that you find under the fender. My car was only 10 years old when these pictures were taken, but it had lived the entire time in New England. Karmann must have never expected these cars to be subject to salty roads. In the picture below you can see how easy it was to put things in the glove compartment from outside of the car. The driver's side had the same easy access to the fuses. At this point I had removed quite a few brackets that were nearly rusted through. Clean up the rusty parts as best you can and get started with the reconstruction.

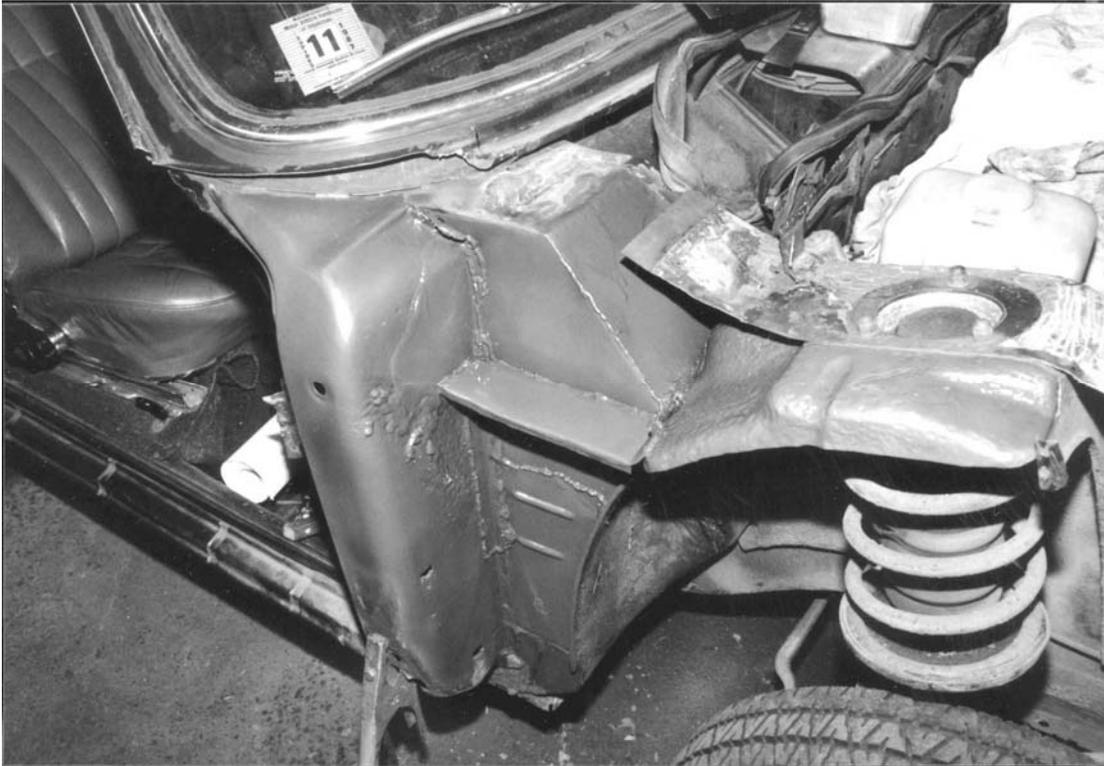
In the picture below you can see the replacement sheet metal I fabricated and MIG welded in place. I did this work in the mid 80s when no patch panels were available. Many of the parts that I fabricated are now available from [Jaymic](#) and [Walloth & Nesch](#). When I fabricated the sheet metal I made sure that the joints I made the same as the original parts. If you open the glove compartment and look at these fabricated parts, they look original. I also MIG welded in small patches for the holes in the cowl.

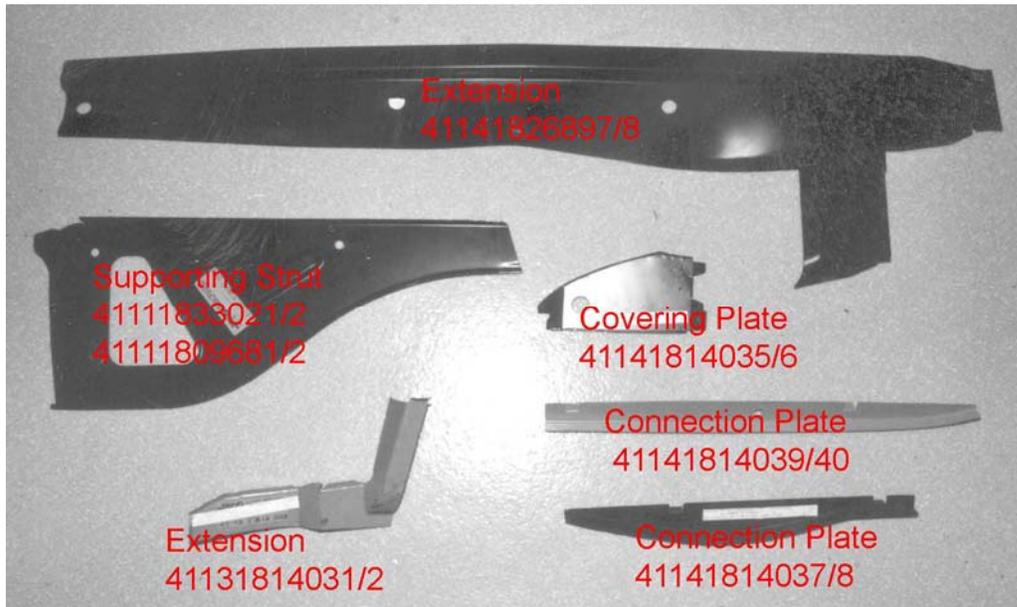
Once you repair the basic structure it is time to start installing all of the reinforcing brackets. The image below shows the parts that I bought.

There are two Supporting Struts shown in the parts manual. The first is item #8 on page 41/3, the second is item #5 on page 41/4. The second one has an extra plate to block a little of the sand from getting into the areas over the glove compartment and fuses. I bought both styles because they were only about \$10 each at the time. I used the second ones, but had to trim the extra plate to clear the fender. The second ones are for a Bavaria and shouldn't be listed with the CS parts. The Bavaria Supporting Struts cost \$31 less than the CS specific ones.

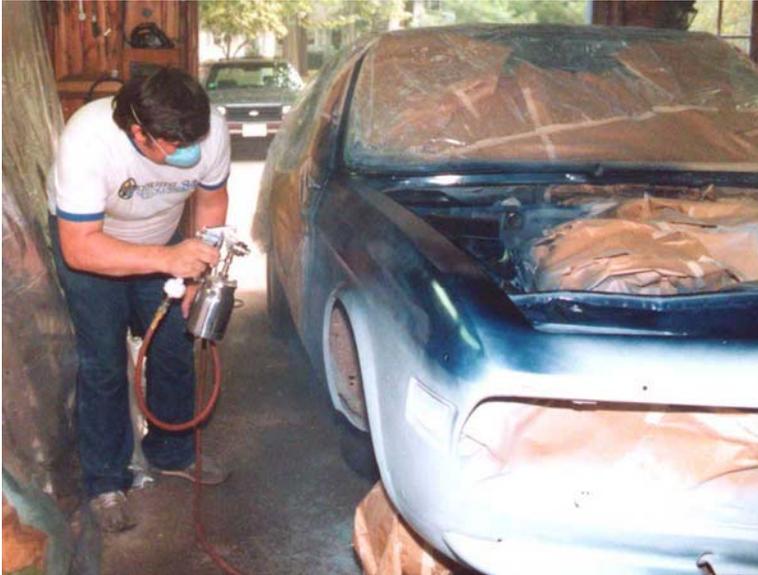
The image below is of a much younger version of me painting the nose of my CS at home. Just a week later we drove the CS to a BMW CCA Oktoberfest.

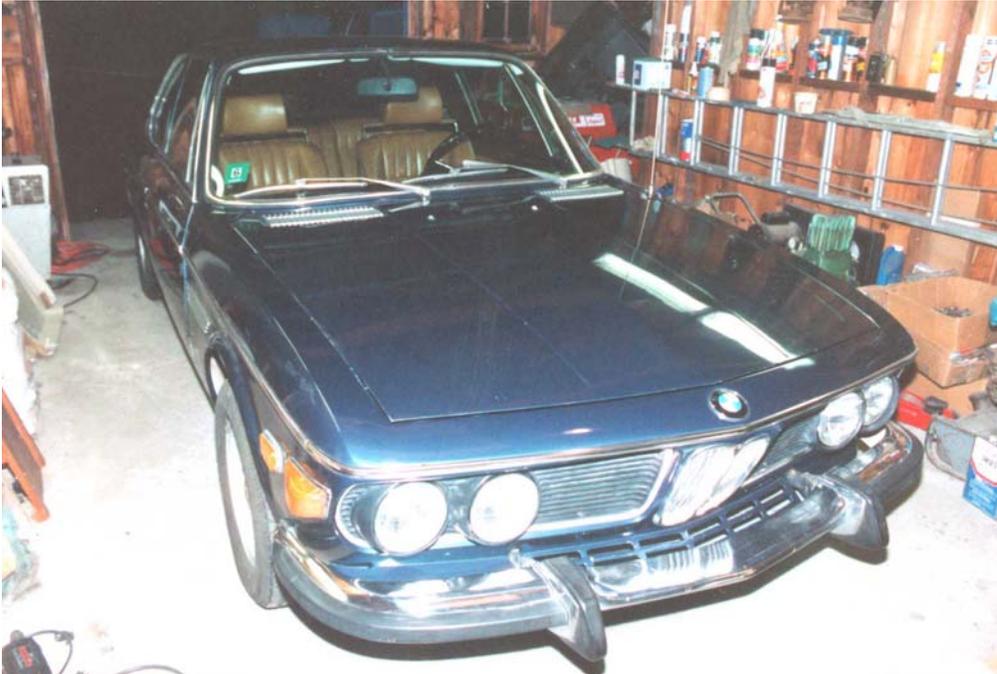
Looks OK for a do-it-your-selfer!
