2002s
—ONLY—

Replacing the Fuel Sender Tube Sleeve

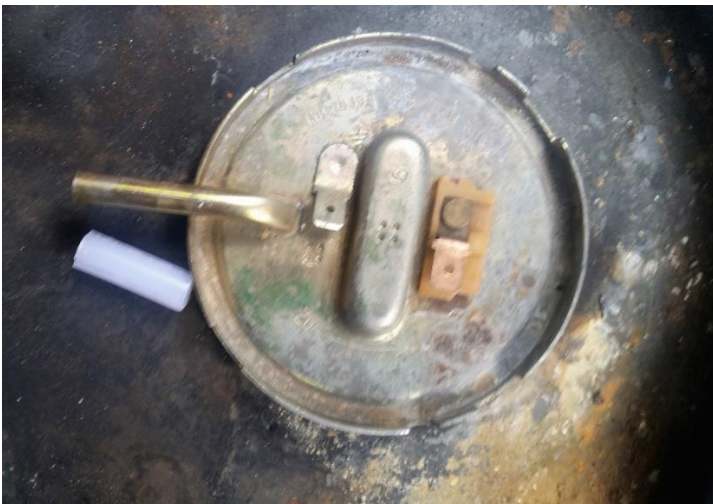
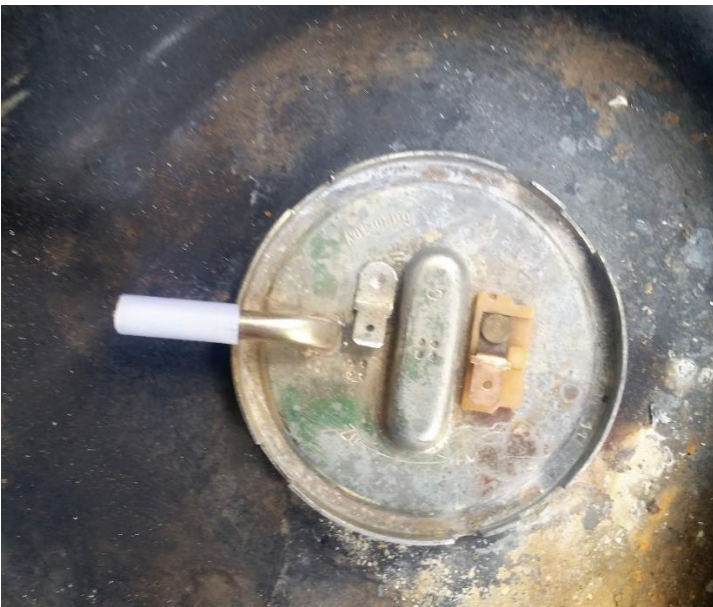
Over time the fuel sender tube sleeve on the 2002s deteriorates allowing gas to leak into the car. Or, more often than not, it was not replaced when new fuel hose was installed because a new one wasn't available.

It is simple to replace. Remove the fuel hose from the sender tube, remove the old sleeve if it is still there, and slid the new one onto the filler tube (you might need to lube the tube with some oil as it is a tight fit). Re-install the fuel hose and voila! One more source of gas smell eliminated.
