Gauges out, Speedo repaired

My speedo stopped working during a highway-speed jaunt a few weeks ago (stuck @ 80 KMH). Thanks to mthomson's write-up on dash removal, I summoned up the courage to take this on. Michael confirmed that he actually got his speedo out without pulling the whole dash, so I gave it a go.

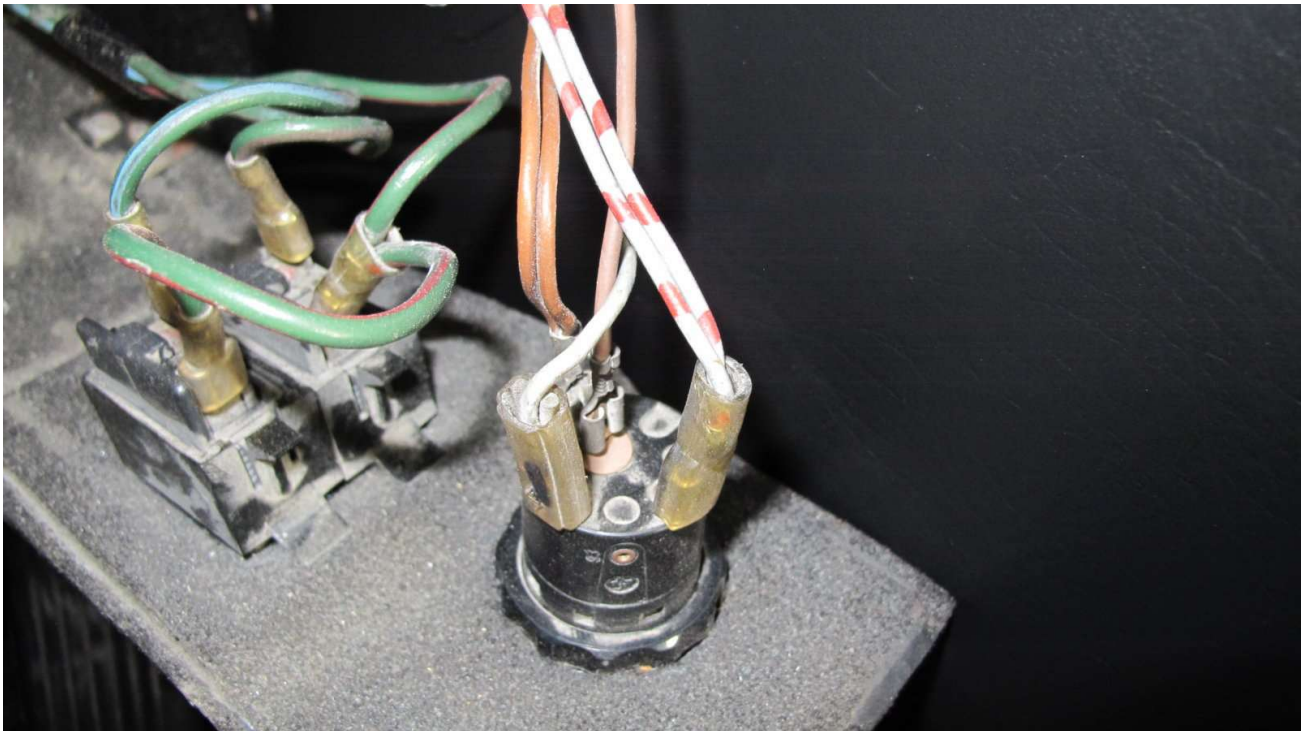
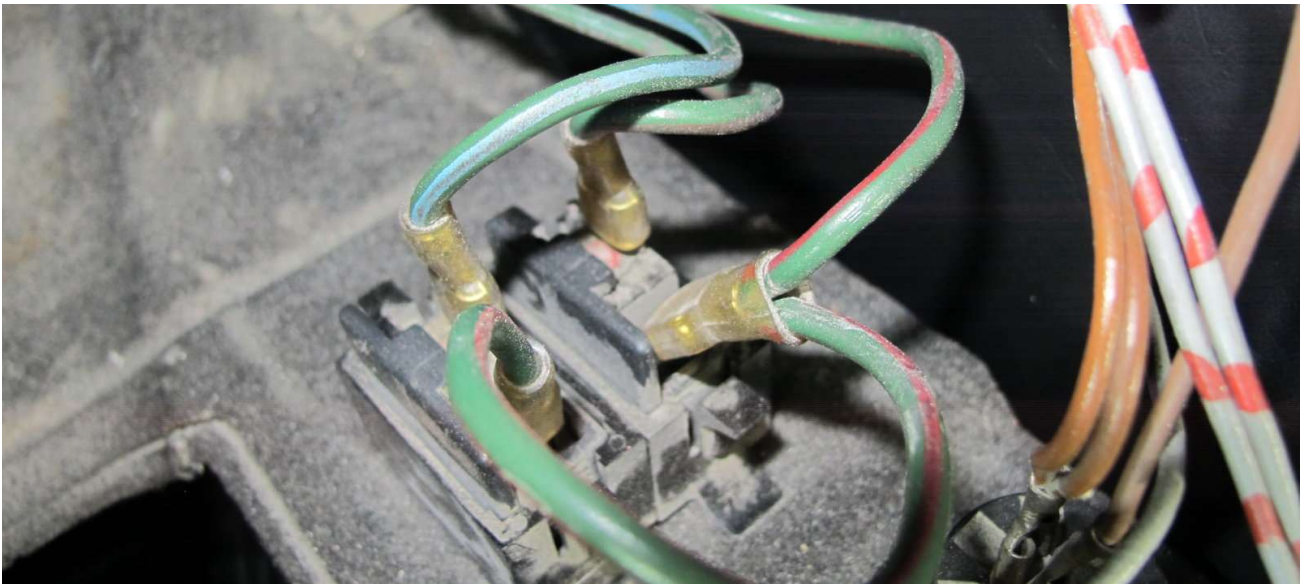
Pulling the panels left and right of the steering column. (right panel circuit breakers

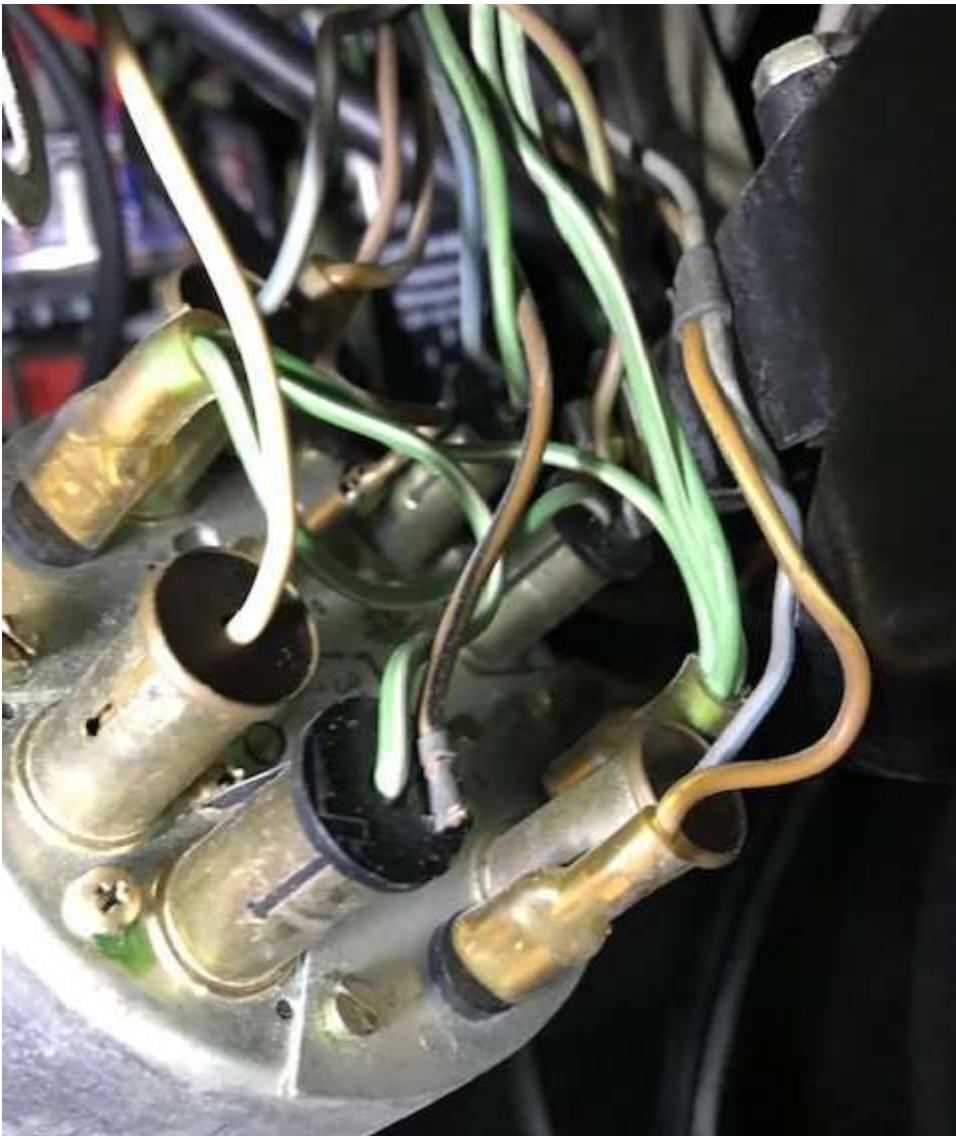
The knurled round nuts holding the gauges in place conveniently have a 7mm end facing out, so with much contorting to lay face-up, it is possible to get them started with a socket and take pressure off of the most accessible knobs on the lower side. It's only necessary to loosen the lower knurled nut. You can then rotate the gauge CCW to free it up from the wood panel.

Getting the fuel gauge out is easiest. There's plenty of room for that gauge to drop down and hang out of the way if it's the speedo you're looking to remove. If you disconnect the fuel/temp gauge, there are a number of connections. I disconnected one gauge at a time, and wrapped a rubber band around the connections to be able to distinguish them later.

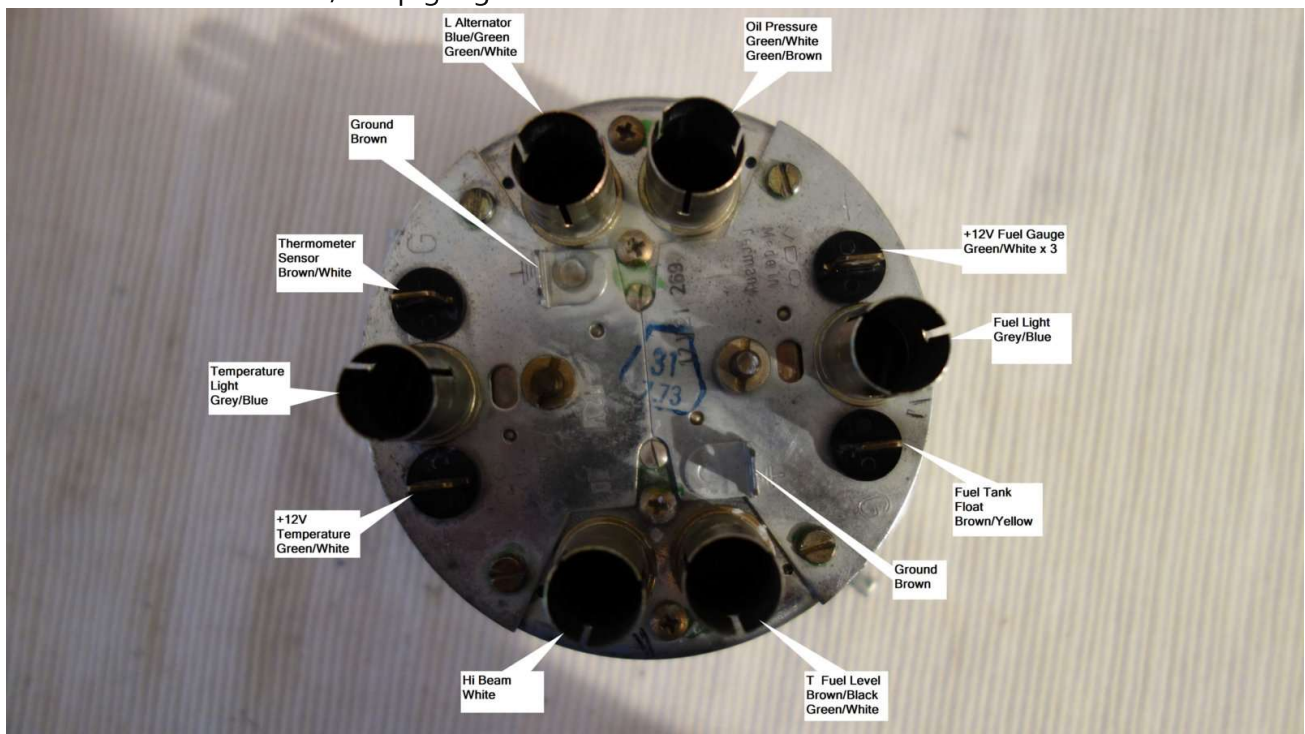
Connections for the Fuel/Temp gauge:

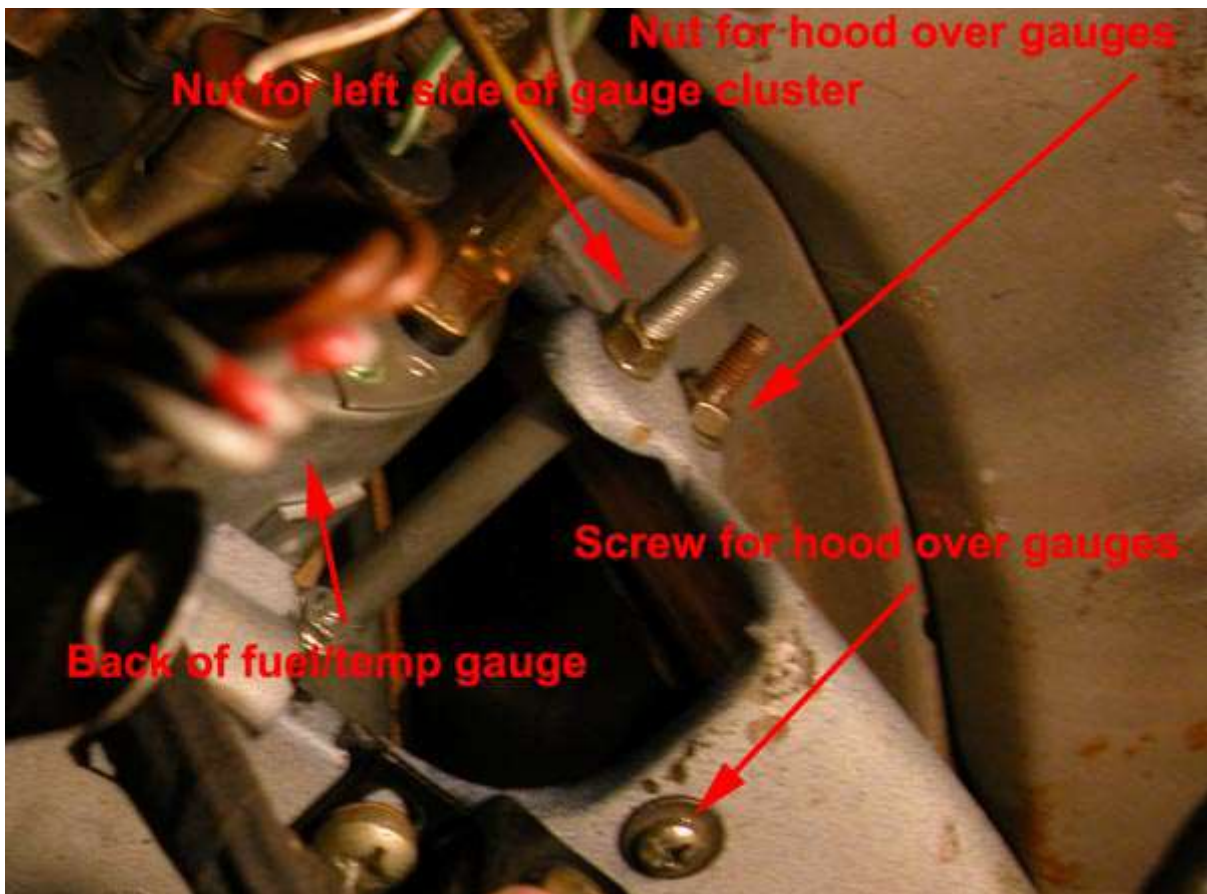
This image from mthompson was critical; if not for this, I would not have known to lift the hood and pull the wooden cluster face outward slightly:

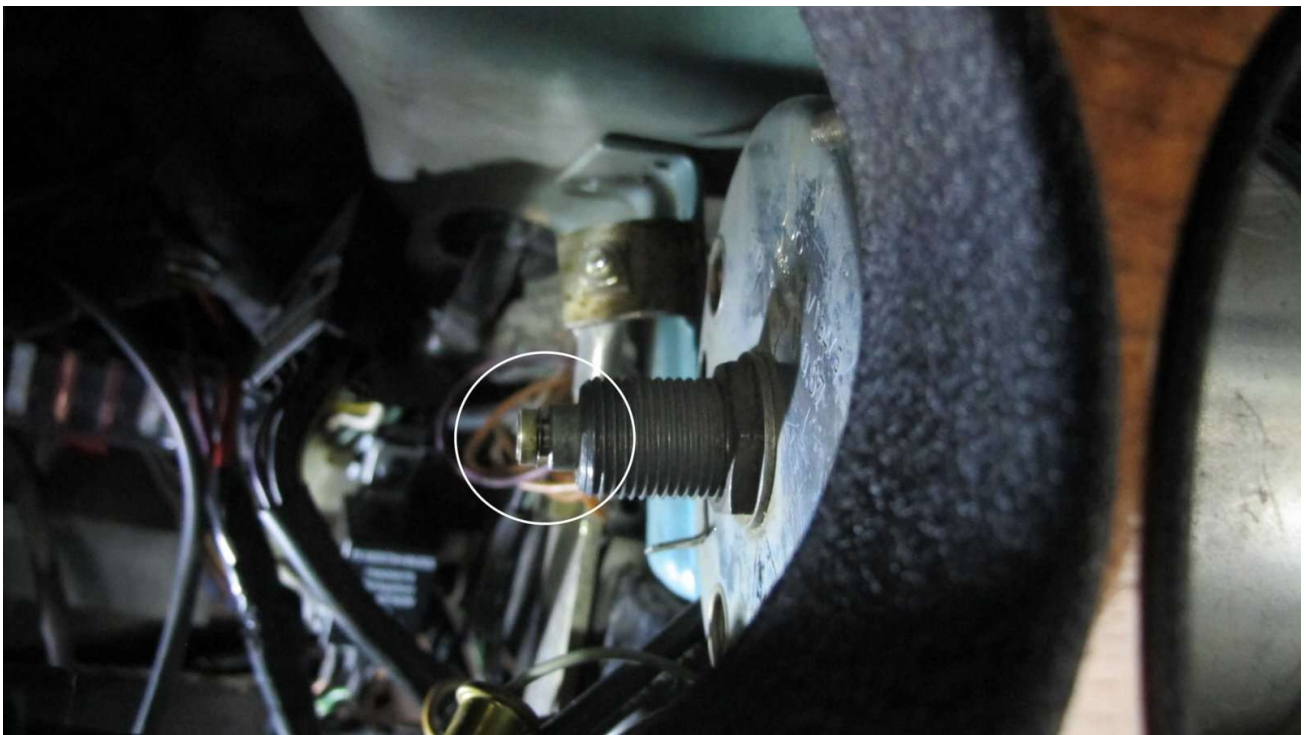
I went after the speedo, and my speedo cable mounting nut was on pretty solid, but miraculously, I could sneak a medium channellock on there and break it loose. After loosening the lower knurled nut I could dismount the speedo. The failure mode was obvious before I even removed it; the shaft/weight in the speedo had become dislocated and caused the needle to hang up. There should only be 0.5mm of play there, max.

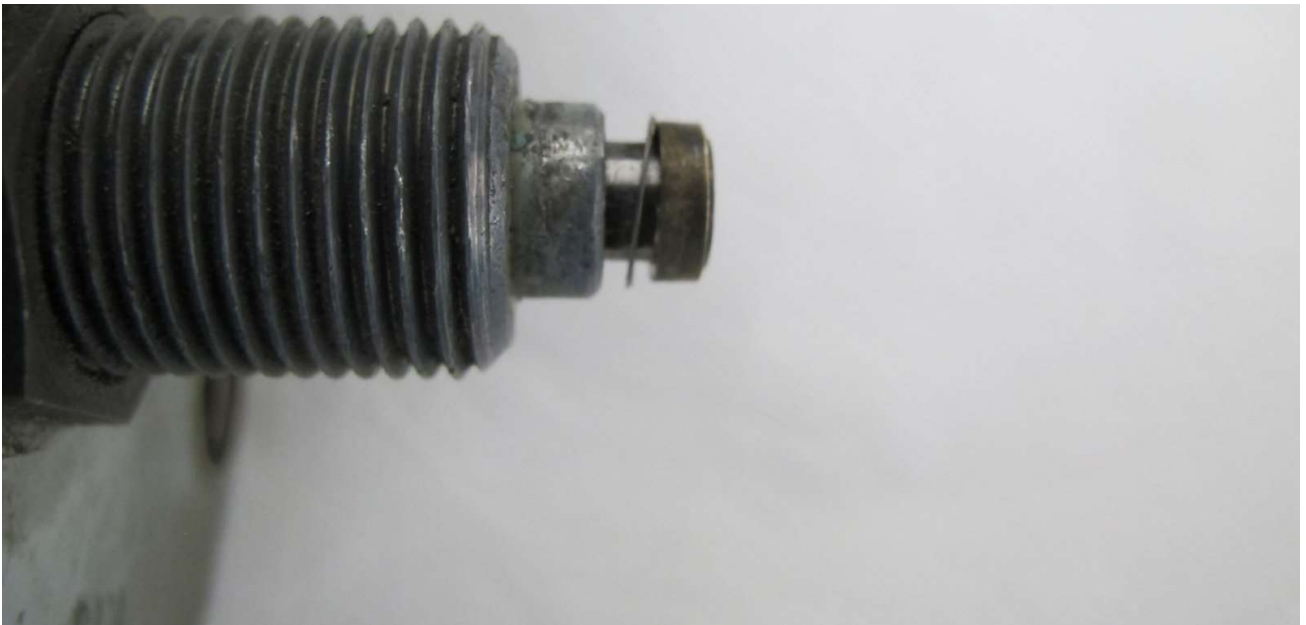
Having the speedo in hand, the shaft play was obvious:

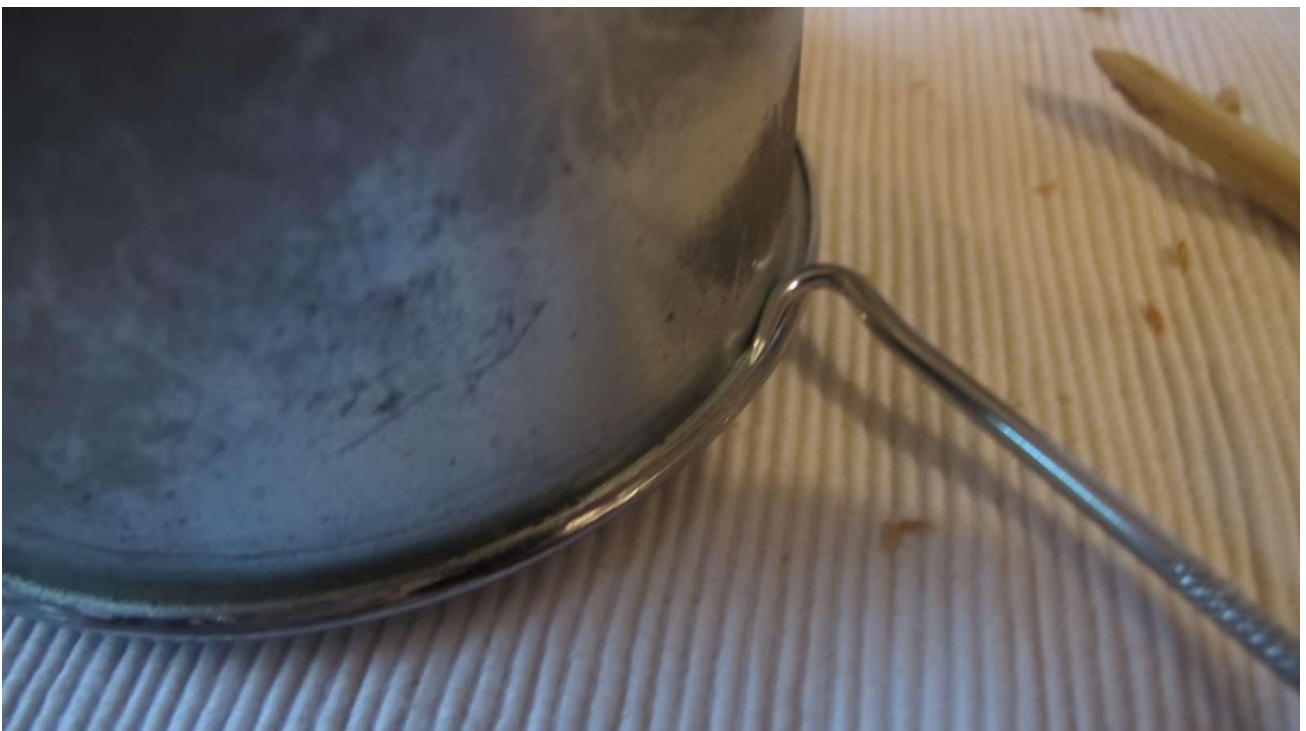
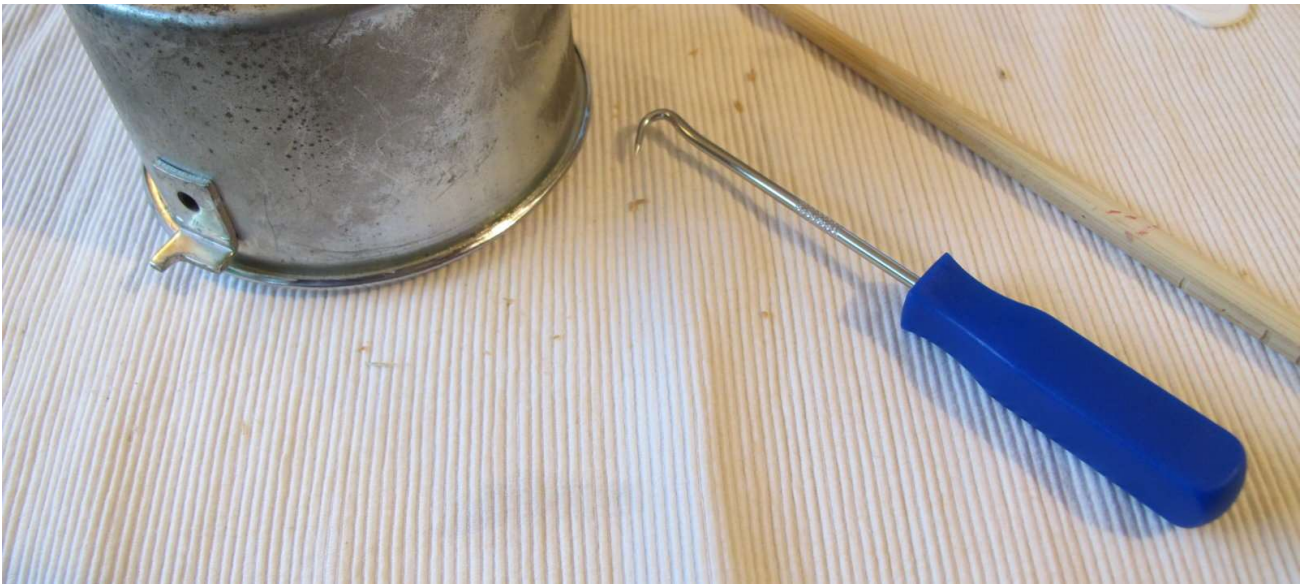
The gauges on an E9 are different from those on a 2002, as they have rings formed around the body of the gauge, so they have to be coaxed off by deforming the ring. I used a hooked pick to start the process, but I mainly relied on my trusty bamboo chopstick.

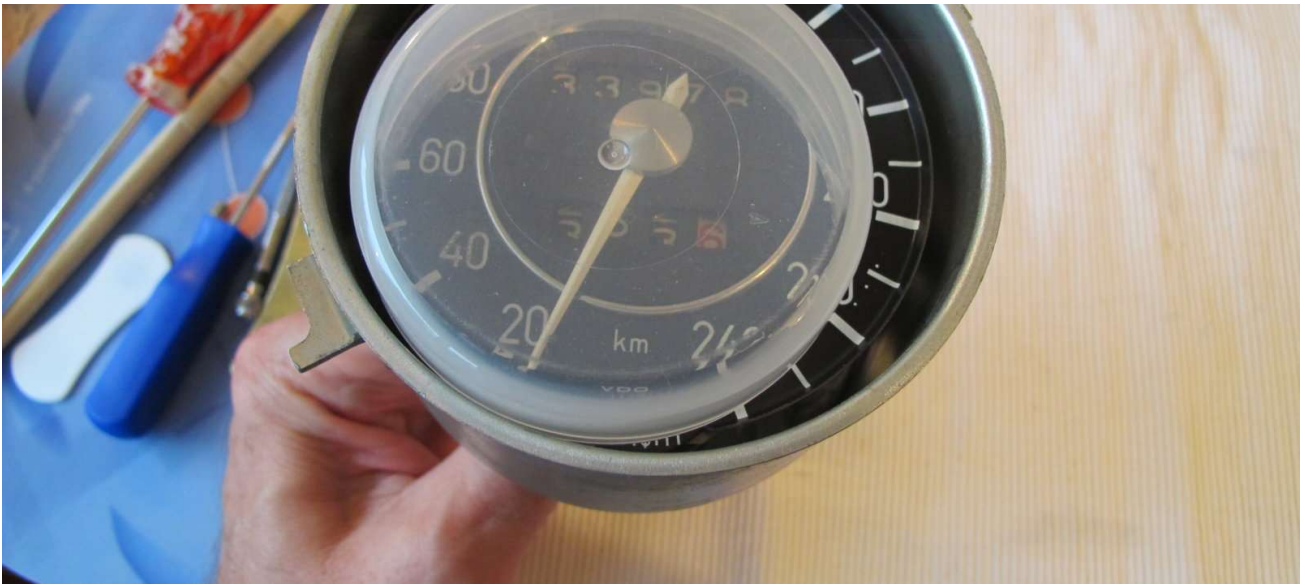
I used a plastic cap to protect the needle when I removed the speedo from the body:

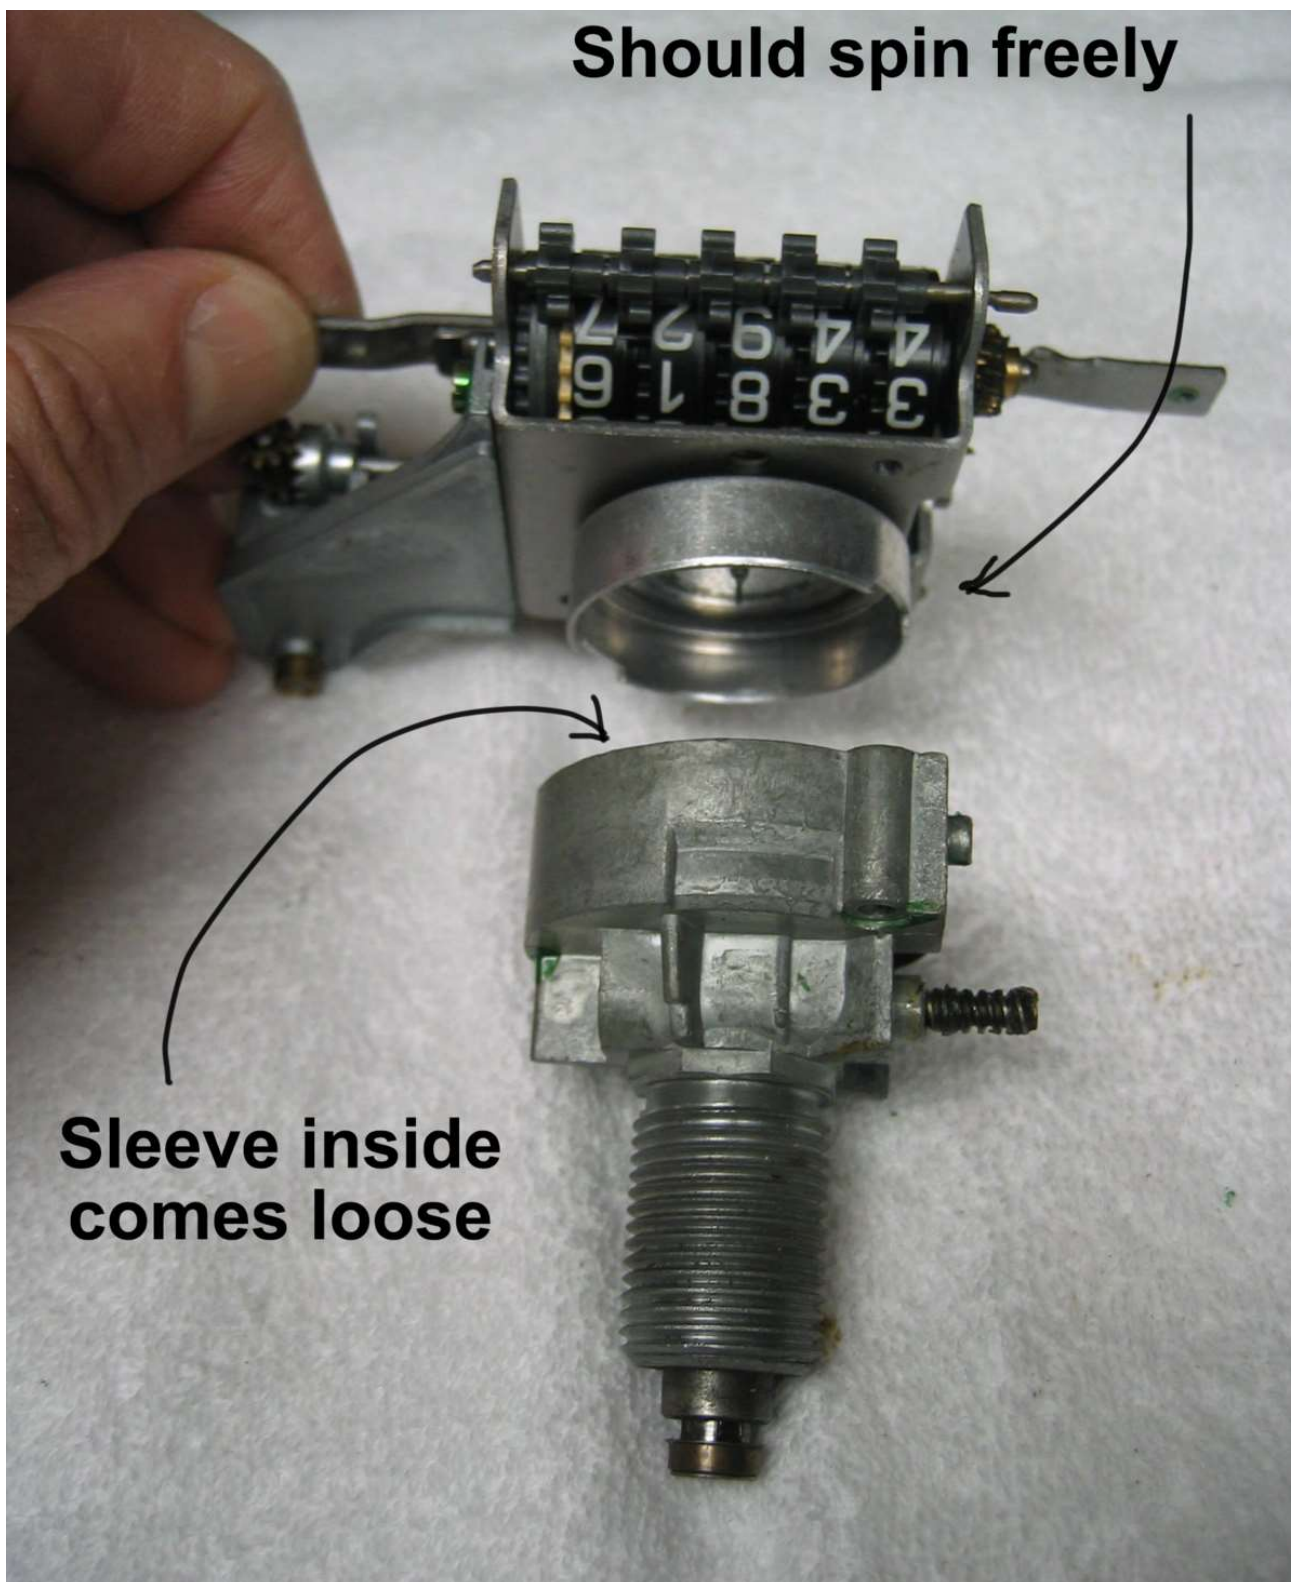
Sorry, but I forgot to take a photo of the the aluminum cup delicately attached to the needle with a light spring in between. The iron weight spins within the aluminum cup and creates magnetic eddy currents that cause the needle to deflect as the weight rotates. The faster the weight rotates, the more the cup/needle deflects against the spring.

This image is from PaulTWinterton on the BMW 2002 FAQ:

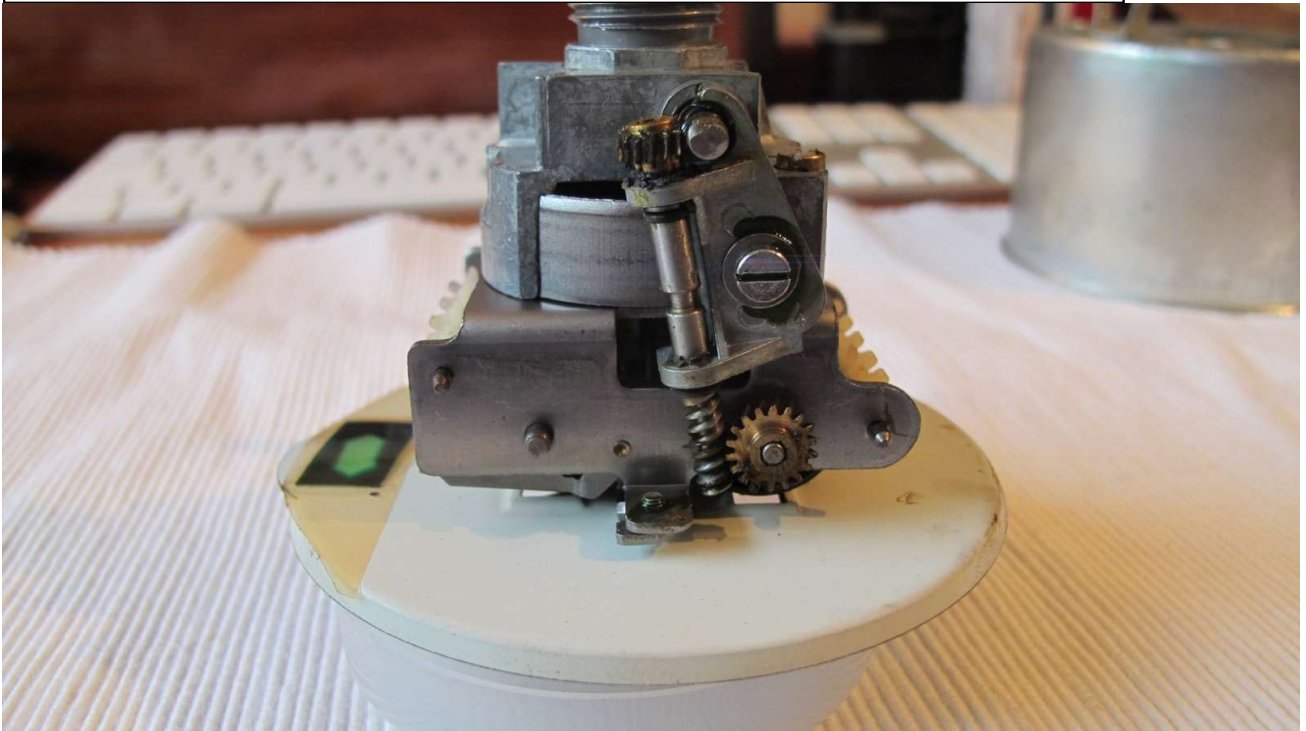
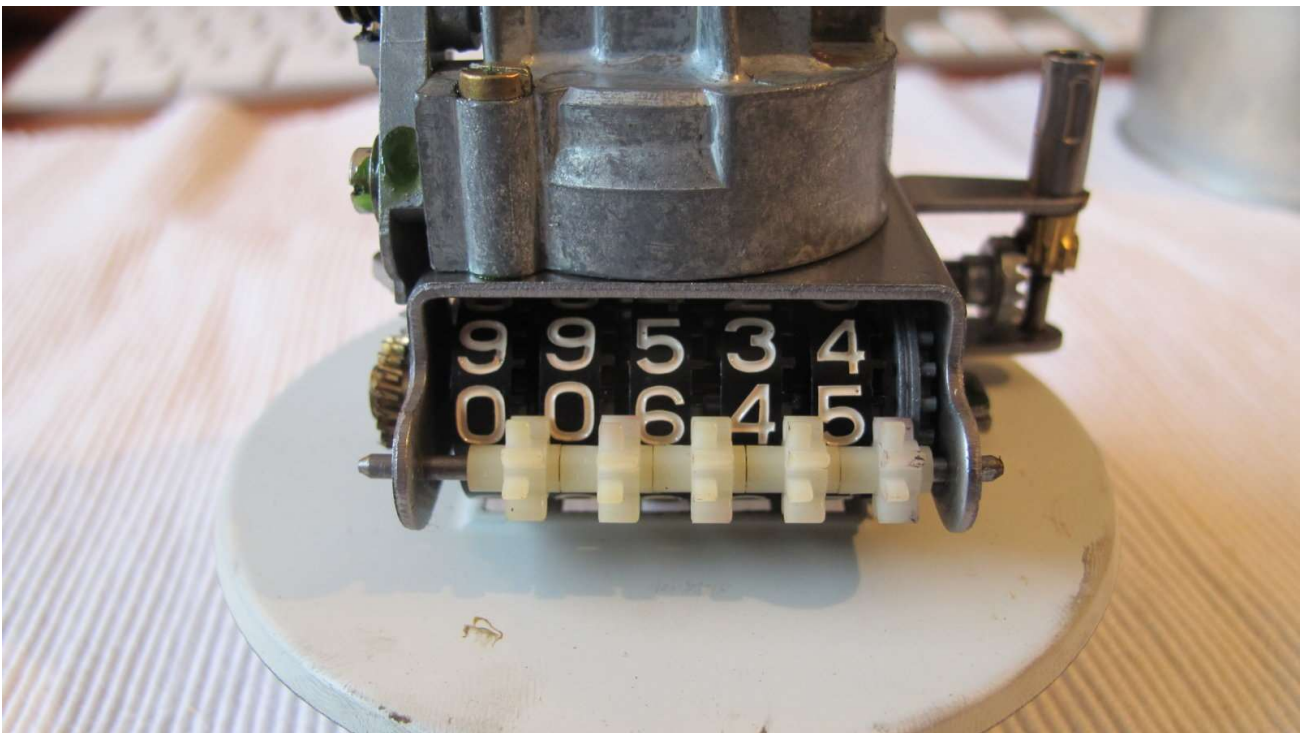
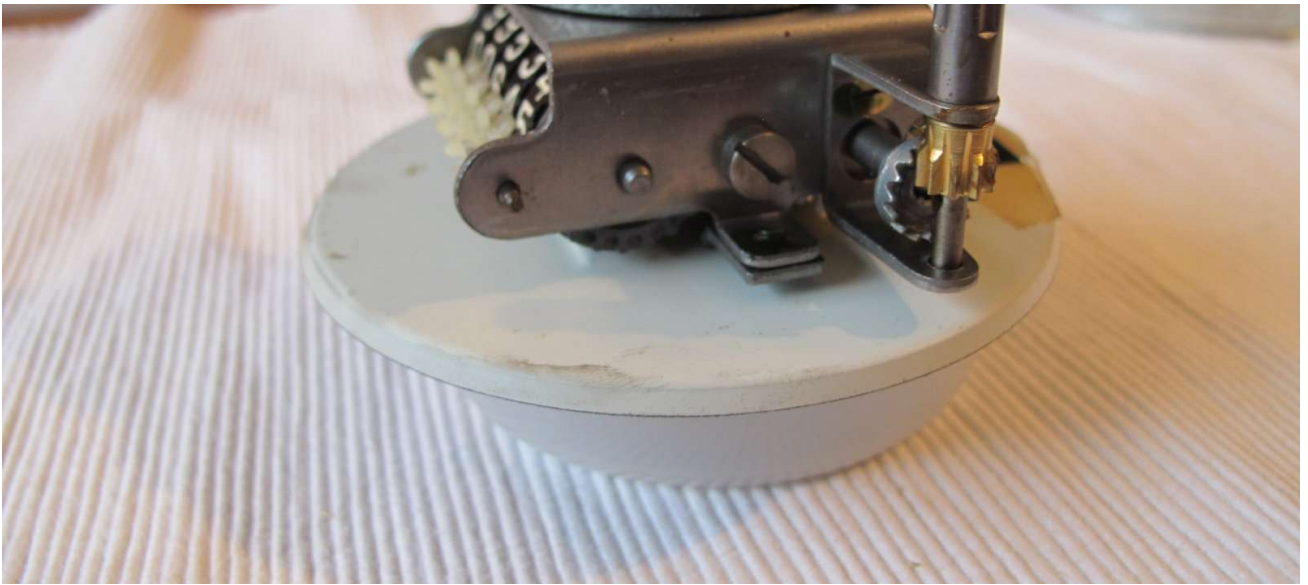
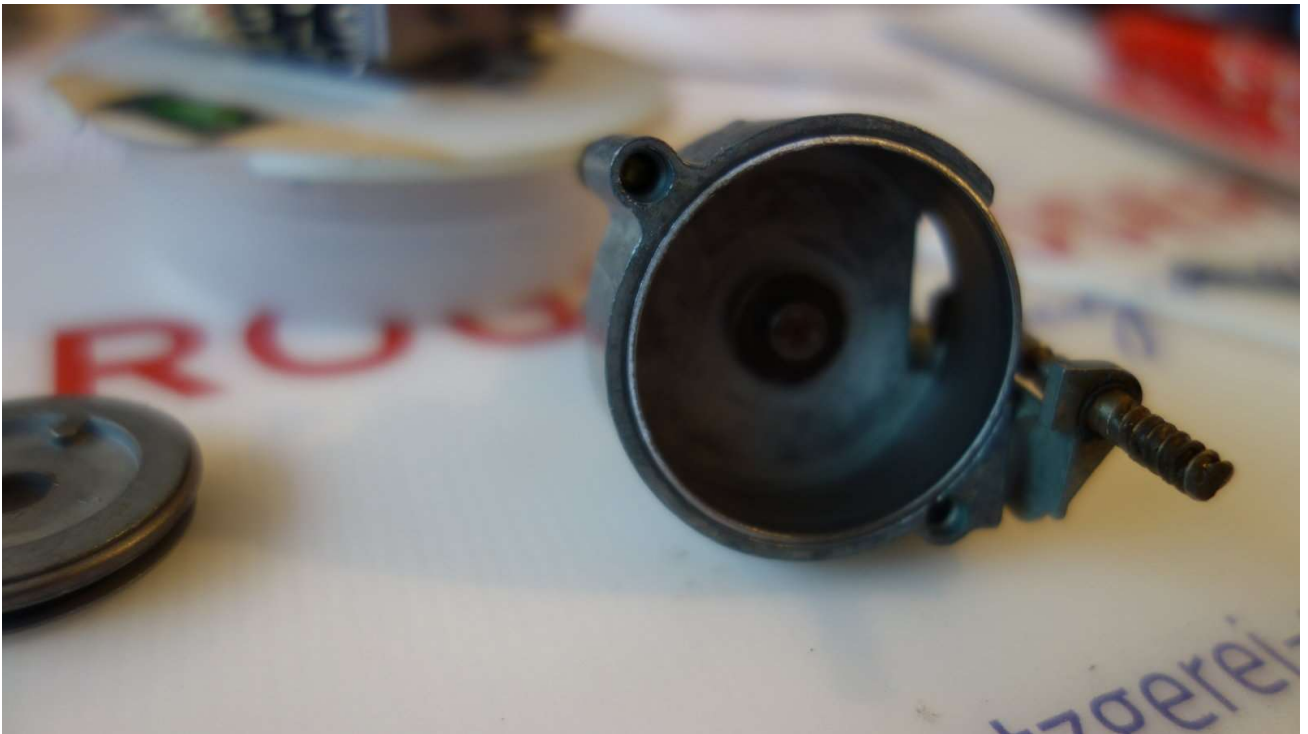
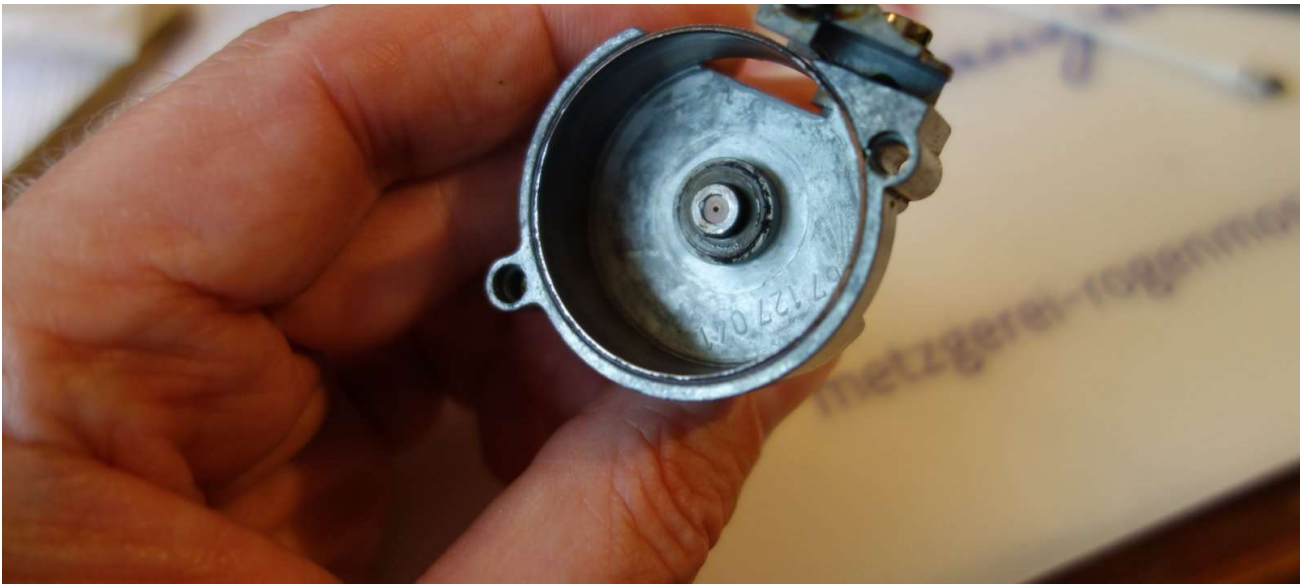
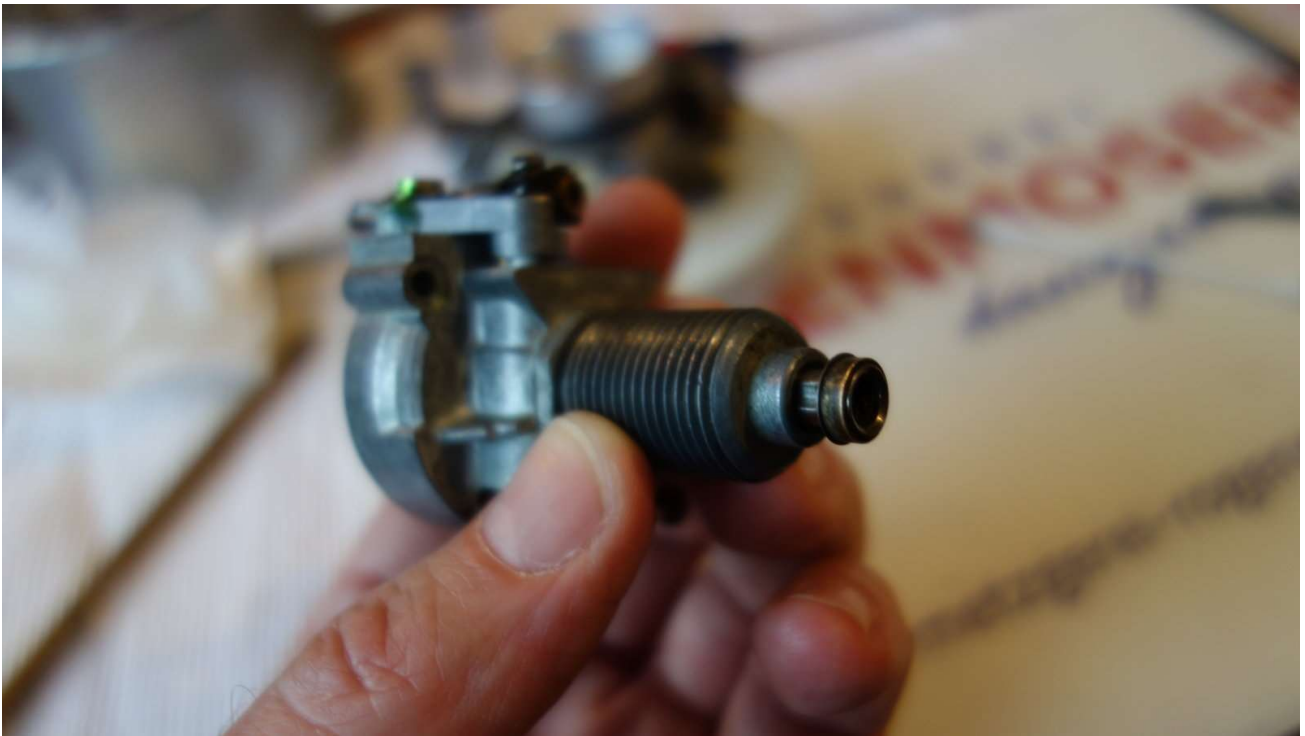
I followed this video from FunkyLaneO on the FAQ that shows how to repair the speedo:

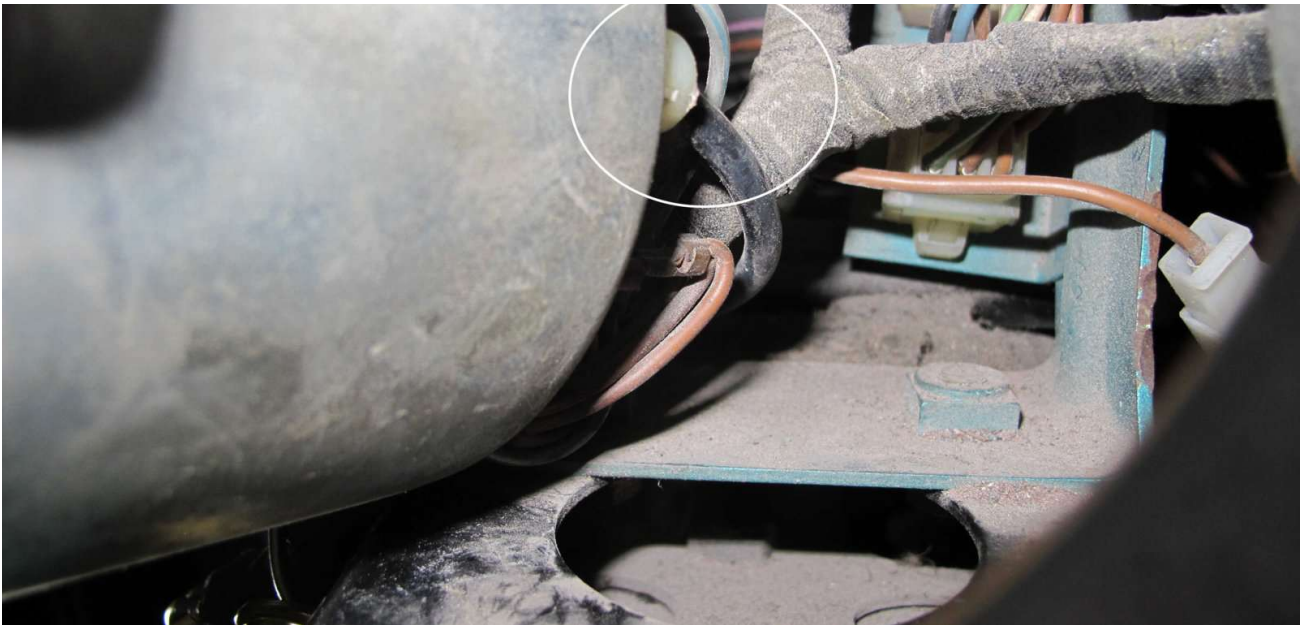
Important note: Pay attention to how the speed odometer cable is routed so that you can route it the same way upon re-installation. This, and having the odometer cable pop out a few times caused the re-installation to be pretty trying.

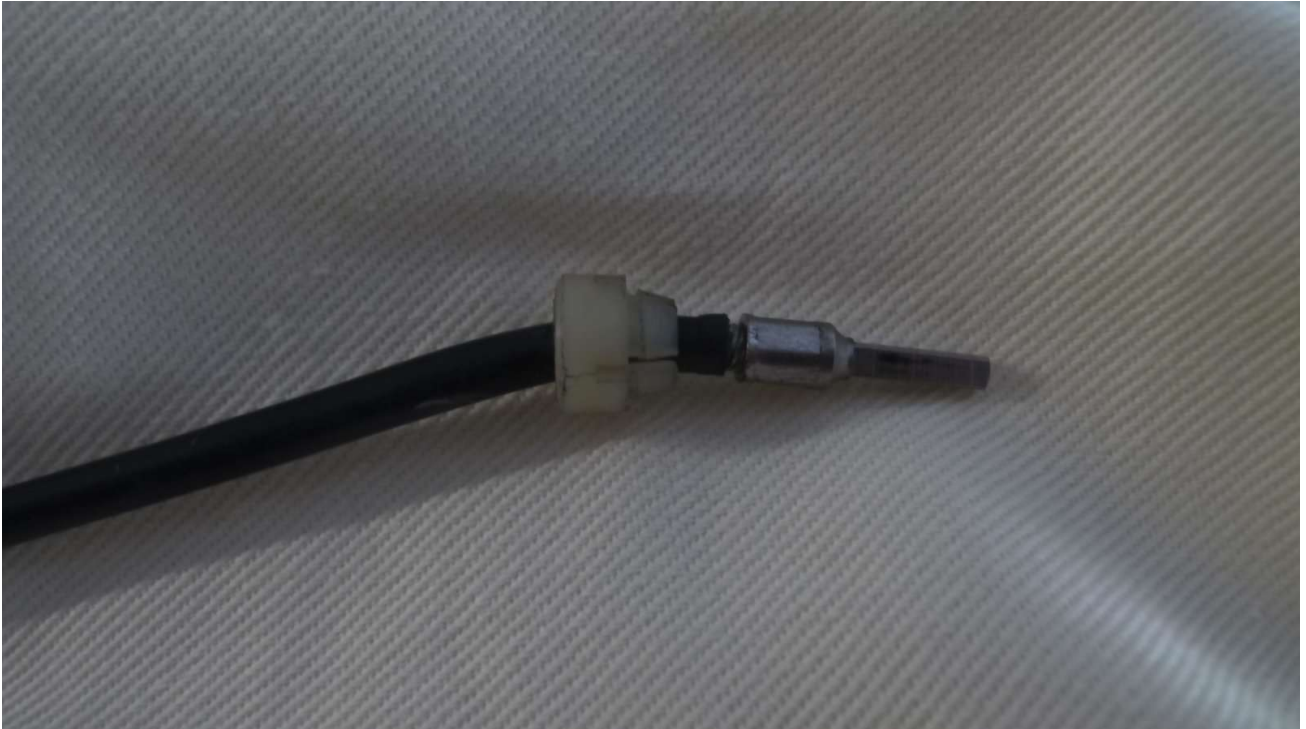
And make sure that the cable is seated correctly and the plastic mount fully seated when re-installing:

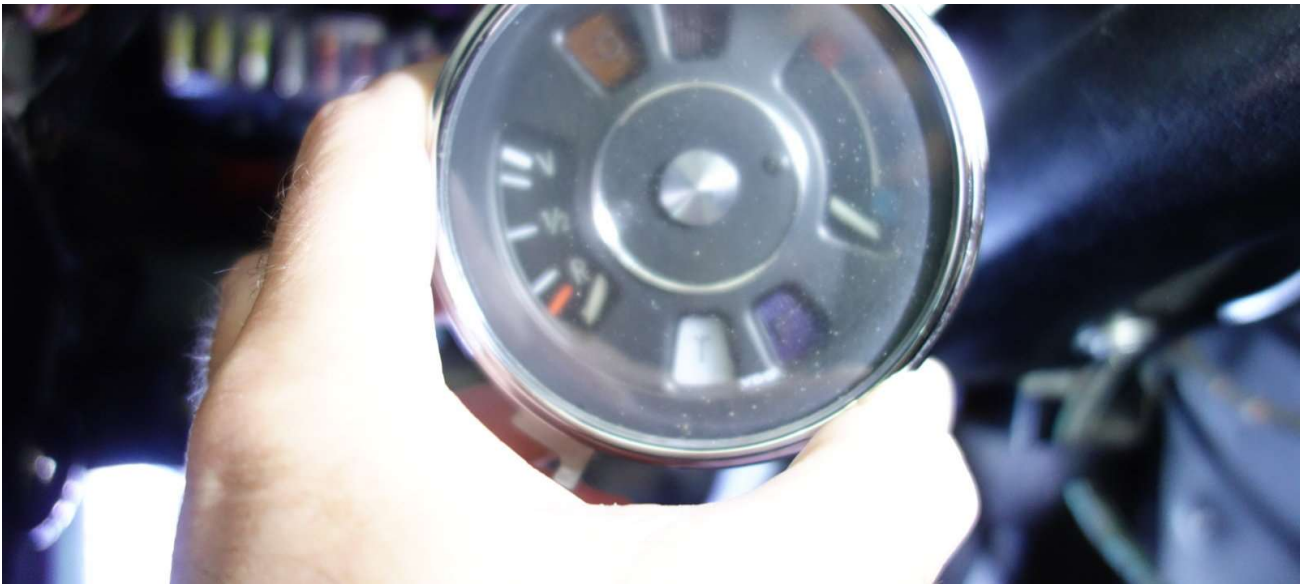
My Fuel/Temp gauge glass was so cloudy that I could hardly read the gauges:

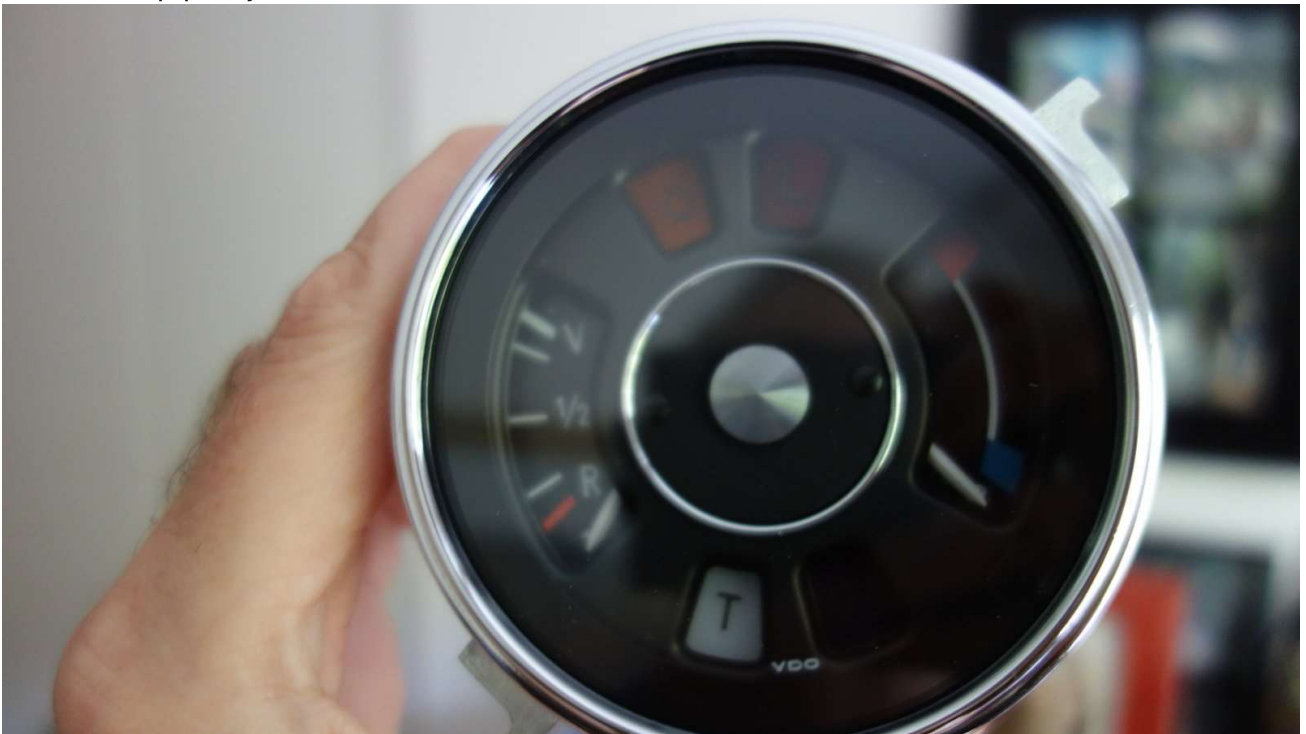
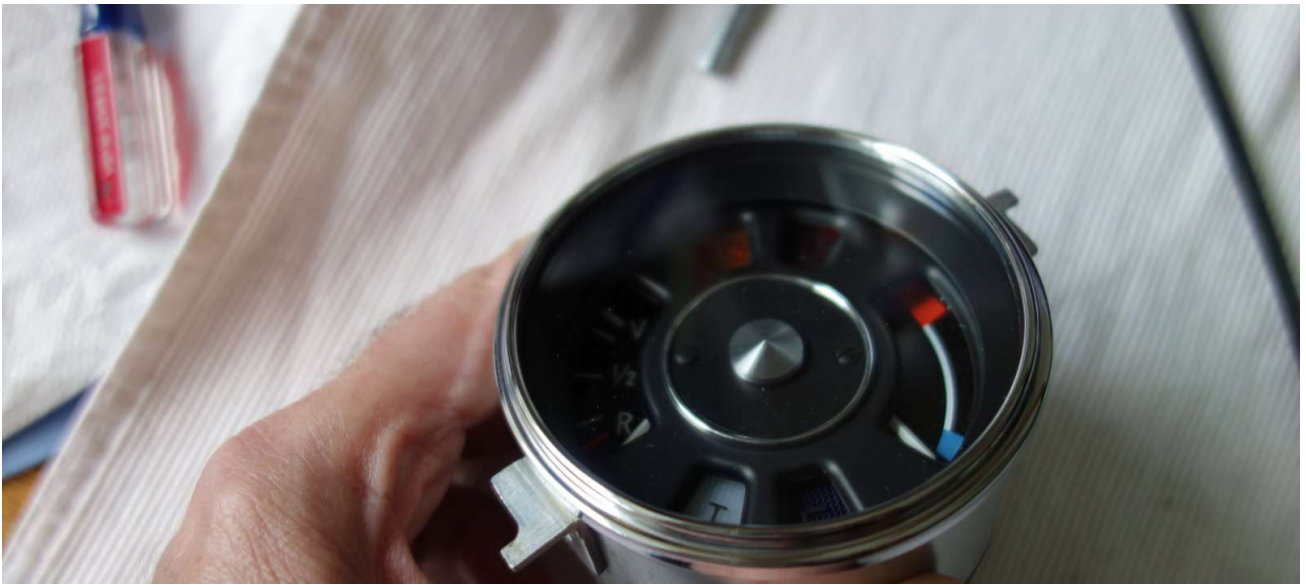
This chrome ring is actually a bit more challenging than the speedo, but with patience, it yielded. It cleaned up pretty well:
