Gauges out, Speedo repaired

My speedo stopped working during a highway-speed jaunt a few weeks ago (stuck @ 80 KMH). Thanks to mthomson's write-up on dash removal, I summoned up the courage to take this on. Michael confirmed that he actually got his speedo out without pulling the whole dash, so I gave it a go.

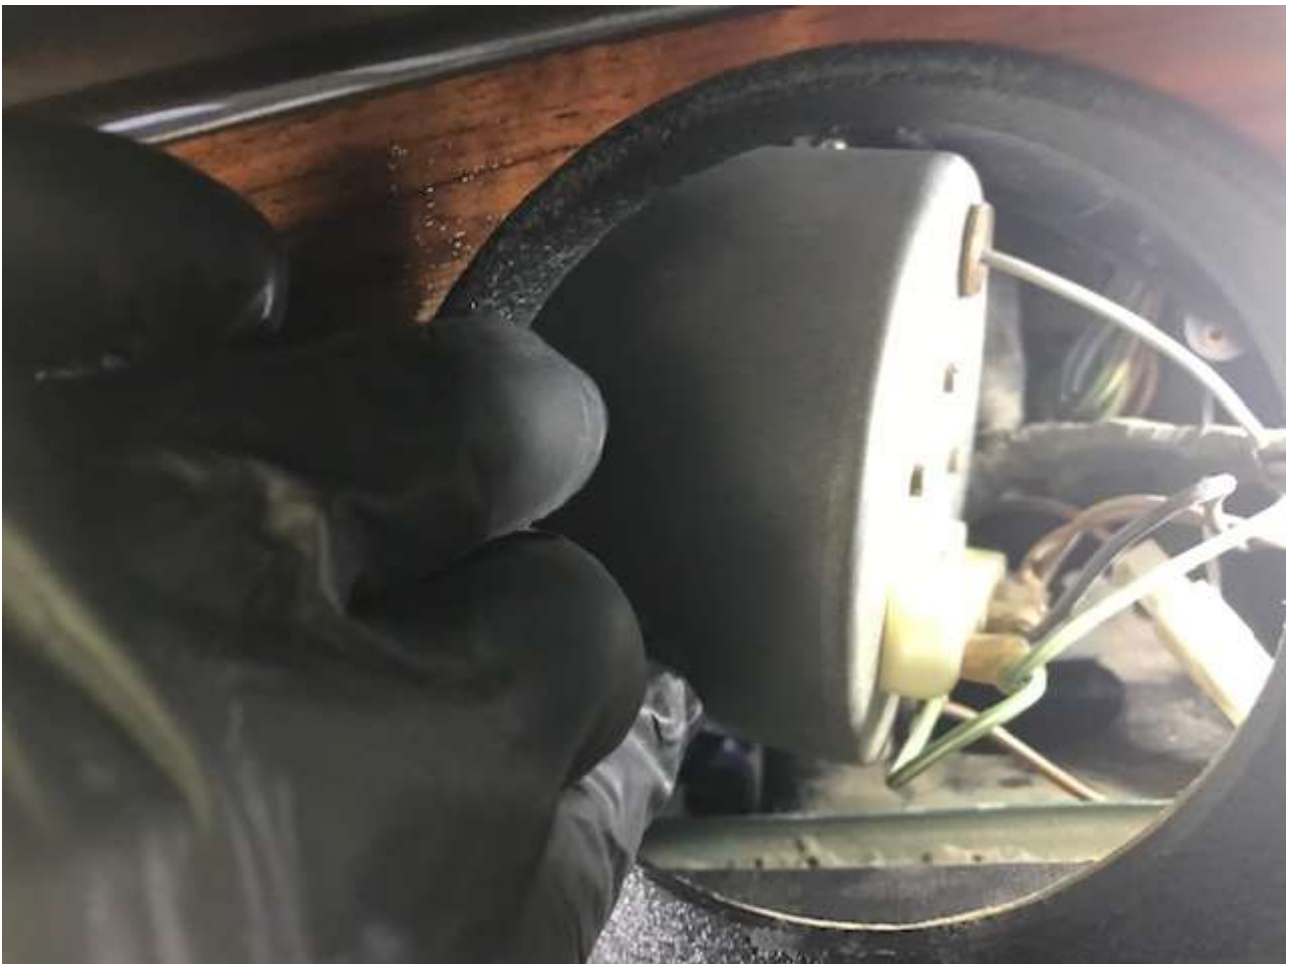
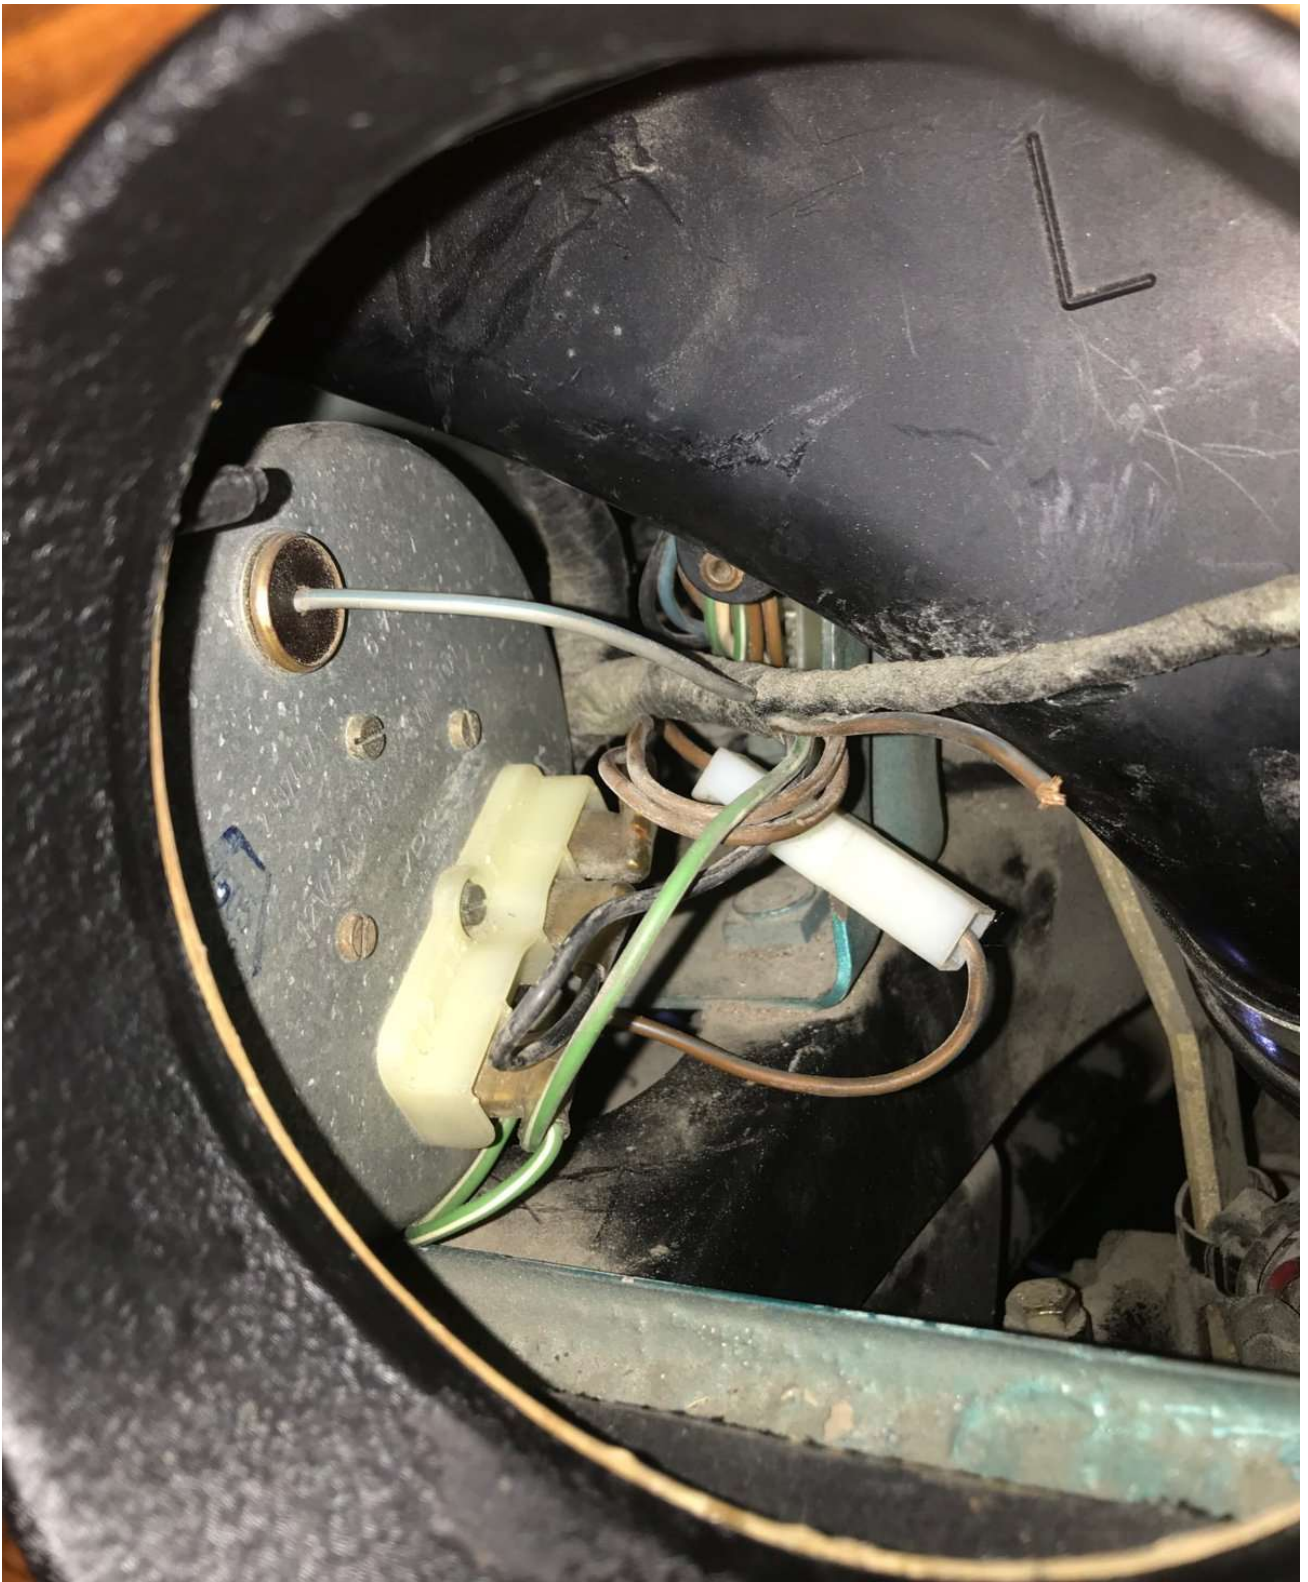
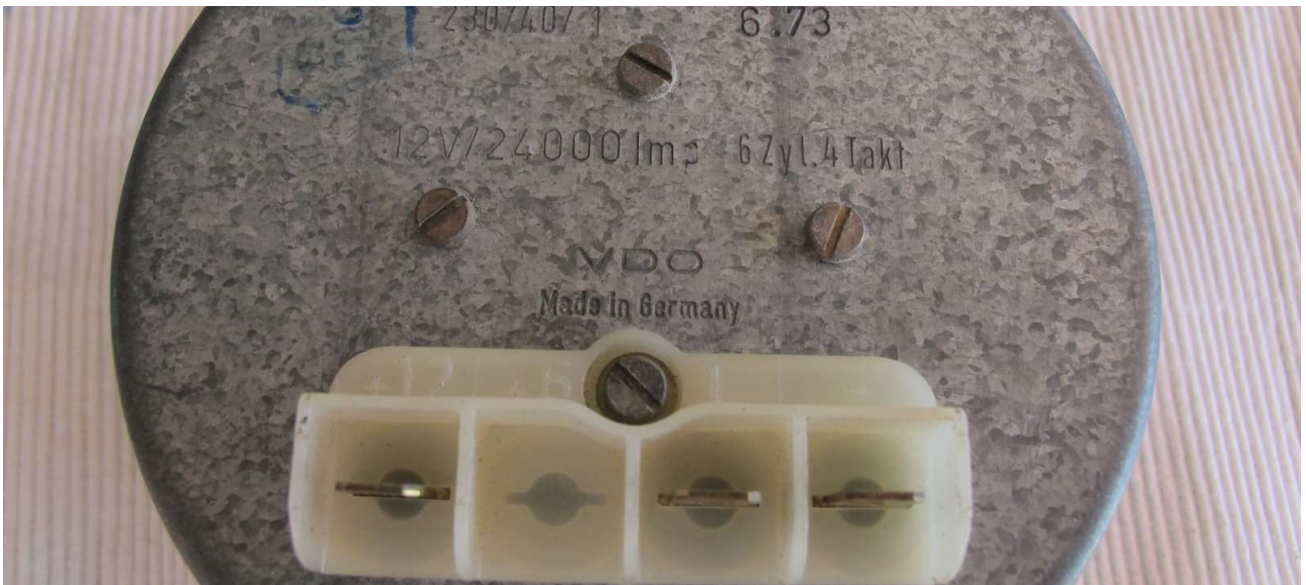
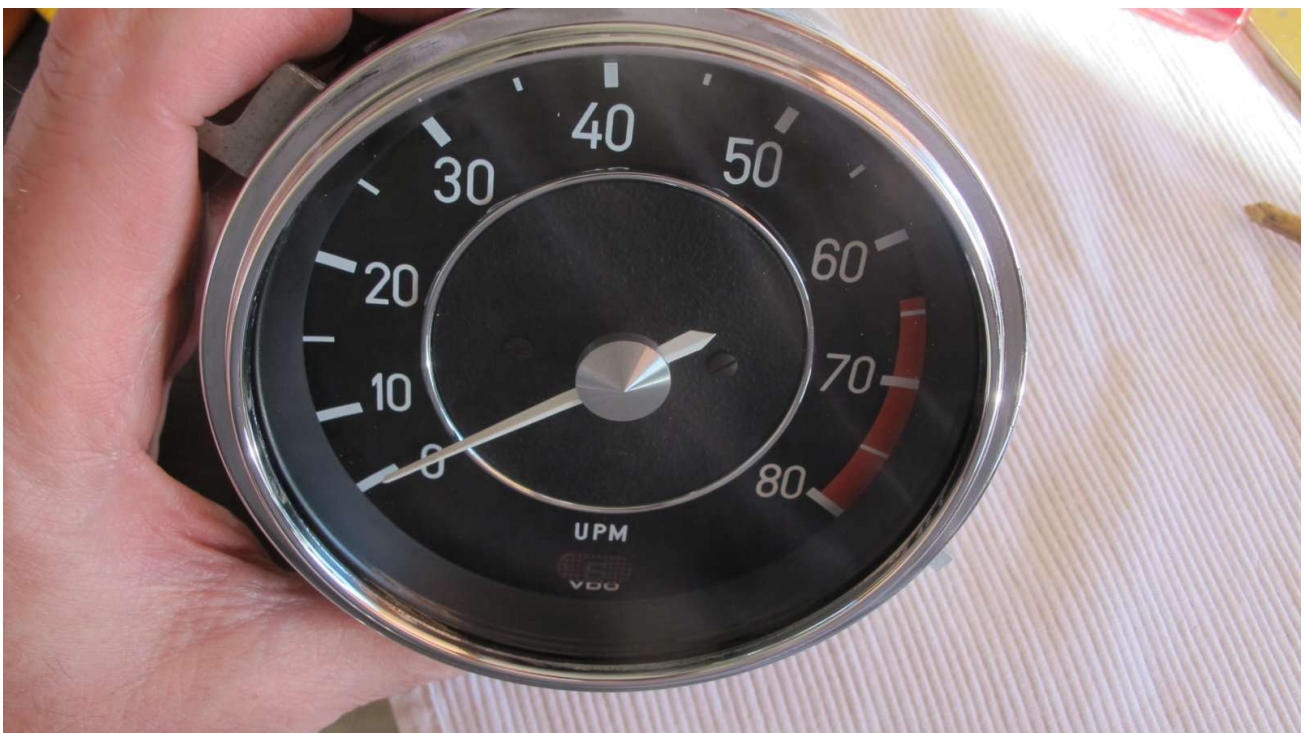
I was encouraged by the results of these two gauges, so I decided to remove the tachometer and clock as well.

I didn't disassemble the clock, as it seems that somebody might have cleaned it in years past.

Interesting that my clock is different from Michael's. His is similar to a 2002 clock, mine has a metal body. It seems that they actually designed it so that the solder fuse could be repaired without disassembling the clock.

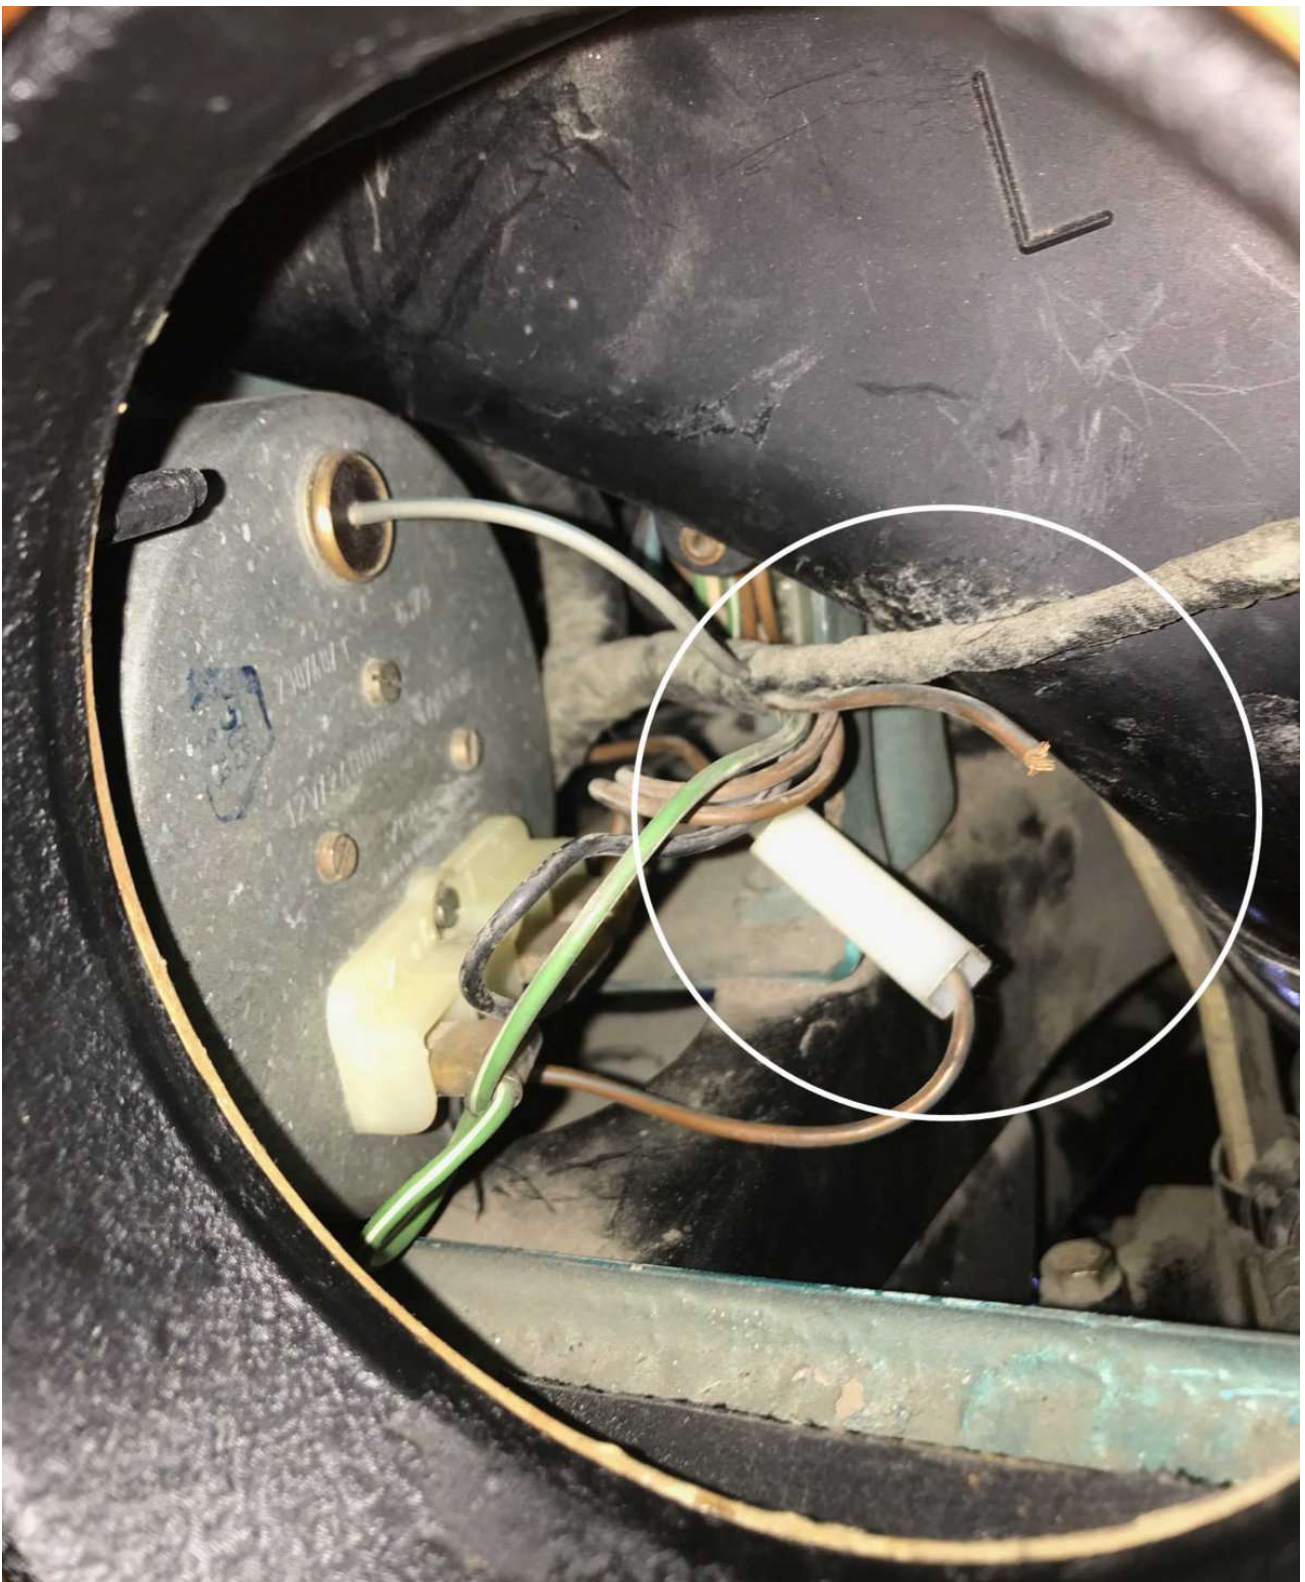
I noticed that this wire had been cut or broken, so I traced it out. It is the brown/grey wire from the brake fluid reservoir. It comes from the white connector behind the speedo. The brown cable with white connector is the e-brake line that appears to have been re-wired. It should also come through the same connector. They should join at the connector rear of the speedo, so I jumpered them together at this connector.

Unfortunately, the wire that was cut seems to be grounded somewhere on its path, so when I got everything back together, I found that it gave a brake fluid fault.

The brake fluid sensor itself is working correctly. By then I had all of the gauges installed and access to the connectors was blocked, so I ended up cutting the connection, but leaving enough wire to come back to it later.
